Investigation of a Sheffield Structural Tile Floor Failure Indicates a Dangerous Design/Development Oversight

Howard J. Hill¹

Abstract: The Sheffield Brick and Tile Company produced a series of structural tile units that were used to construct floor and roof decks. The tiles were used as integral components in composite concrete, tile, and reinforcing bar deck systems. After roughly 40 years of service, the Sheffield Tile Deck System (STDS) in a school building failed. Investigation of the failure provided a clear indication that the design/development process overlooked a potentially critical feature of these systems. The investigation also revealed a mechanism whereby an STDS could provide adequate service, then fail in a rather abrupt fashion. During the investigation, reports of other STDS failures were discovered, including some referenced in Sheffield Brick and Tile Company correspondence to an owner of a STDS, suggesting he have it checked out by a qualified engineer.

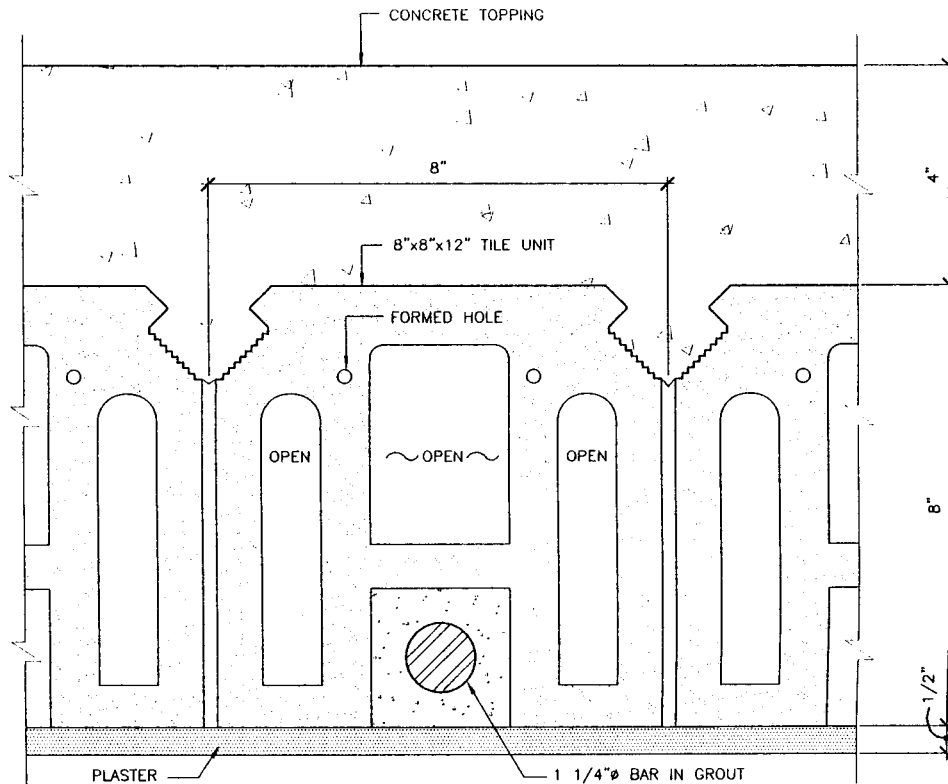
Fig. 1. Transverse cross section

For many years, the Sheffield Brick and Tile Company of Sheffield, Iowa, produced structural tile units that were used in conjunction with concrete and reinforcing bars to build structural floor and roof decks. A typical Sheffield Tile Deck System (STDS) consisted of an essentially solid array of tile units, covered with a cast-in-place concrete topping. Reinforcing bars were incorporated via channels in the bottoms of the tile units. A schematic transverse cross section through an STDS is shown in Fig. 1.

- Clay tile units with the words “Sheffield Load Bearing Tile” on the sides,
- Cross-section properties shown in Fig. 1,
- A clear span of approximately 31 ft 2 in. between supporting concrete block walls, and
- A standard tile unit length of 12 in., with one transverse row of units that were about 4 in. long. The row of shorter units was located near one of the bearing walls.

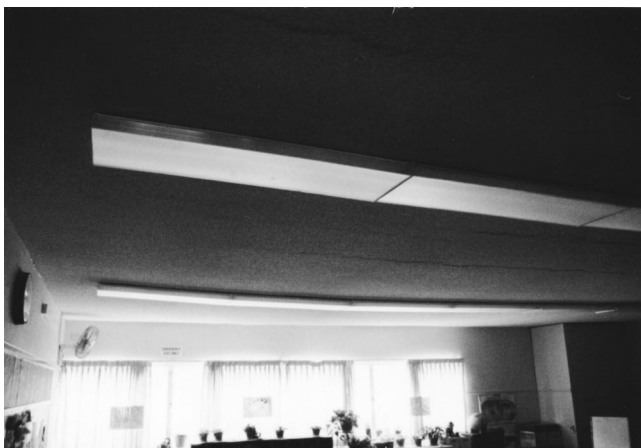
In March 2000, an STDS comprising a classroom floor in a school facility began to deflect rapidly, accompanied by loud cracking noises. After a period of several hours and after sustaining displacements of several inches, the floor apparently stabilized. A photograph of the underside of the floor at this time is shown in Fig. 2. After a period of several weeks, a portion of the floor system fell onto the floor of the room below. A photograph of the collapsed area is included as Fig. 3.

Fig. 2. Underside of sagging floor

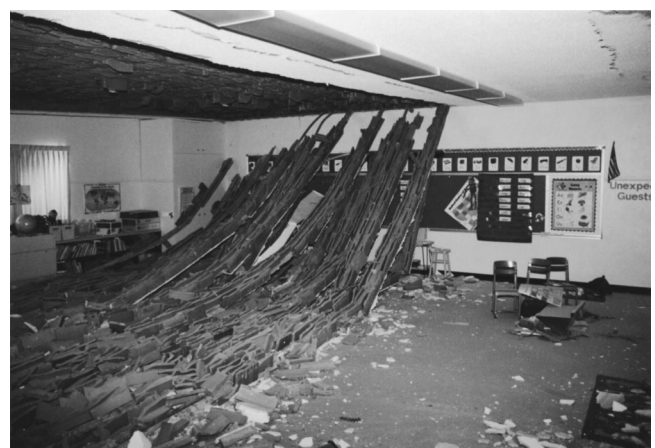
Fig. 3. Collapsed area

As indicated in Fig. 3, the failure of the floor did not involve a loss of bond between the concrete topping and the tiles. There was also no indication of bond failure at either the reinforcing bar/grout or the grout/tile interfaces. The tile units represented the only failed components of the STDS, with the majority of the tiles exhibiting failure near the junction between the web elements and the top flange.

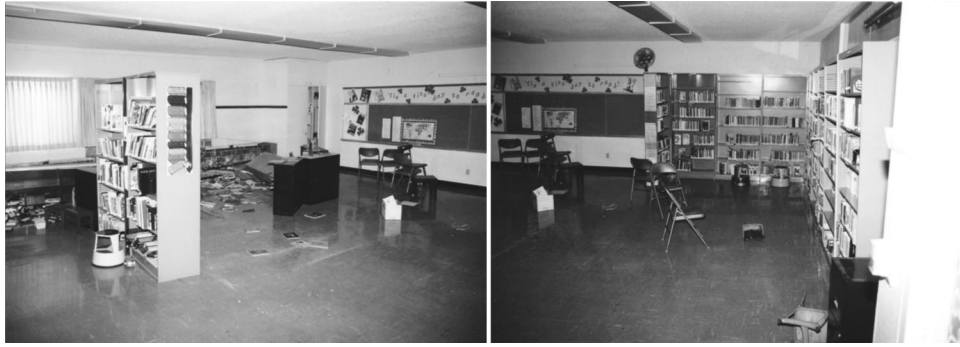
Inspection of the room above the failed floor indicated a modest live load. As shown in Fig. 4, the room contained several bookshelves, primarily arranged around the perimeter, and a few pieces of furniture (several computers and computer tables had been removed before the photographs comprising Fig. 4 were

taken). It was reported that, at the time the floor started to sustain large deflections, it was also occupied by a small number of students and one teacher.

Fig. 4. Room above failed floor

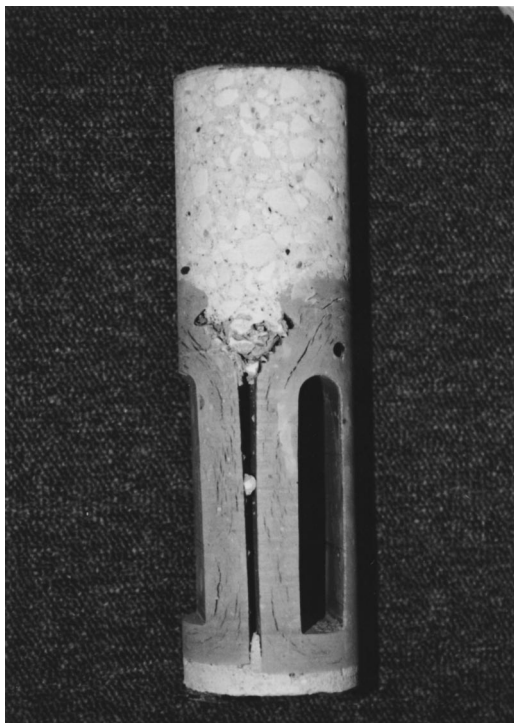
- The concrete topping appeared to be sound and reasonably well consolidated. It also appeared to consist of normal weight material with an estimated compressive strength in the range of 4,000 psi.
- The tile units contained many planar voids that were oriented roughly parallel to the nearest finished surfaces. Examples of these voids can be seen in Figs. 5 and 6.

Fig. 5. Core through intact floor showing voids in tiles

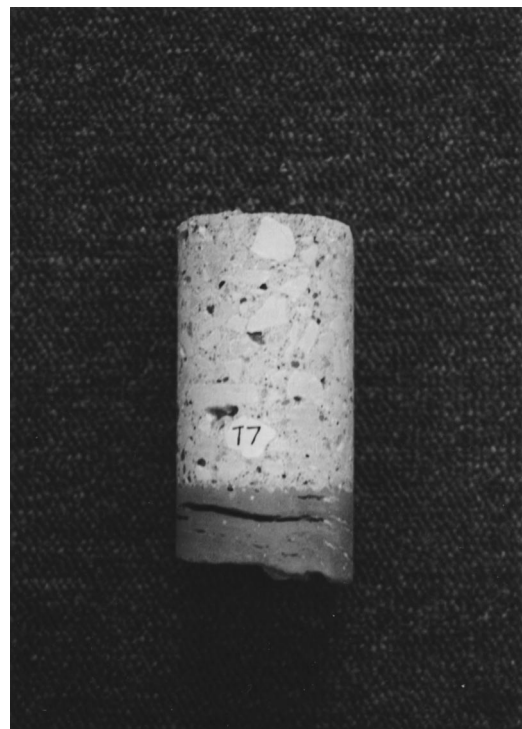
A typical test sample is shown in Fig. 6. This testing indicated a wide range in tensile strengths. At the low end were the samples that were loose after coring (tensile strengths of essentially zero), while the cores that could sustain a test load indicated tensile strengths between 80 and 160 psi.

Fig. 6. Partial core showing large planar void in tile

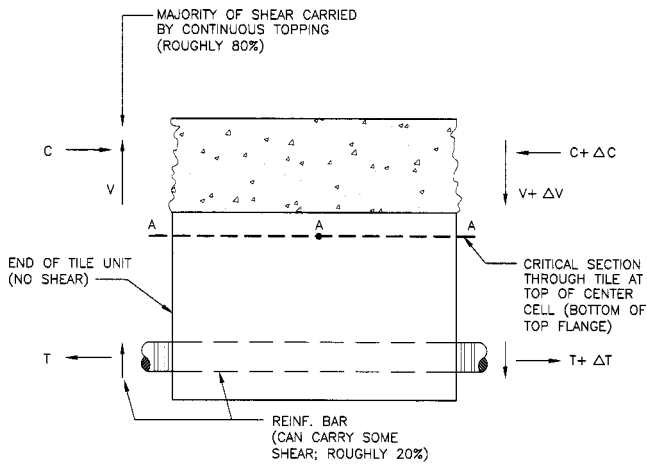
Fig. 7. Free body diagram of single tile section of floor

A free-body diagram of a 12-in.-long section of a one-tile-wide strip of STDS is shown in Fig. 7. As indicated, the vertical shear acting on each end is carried primarily by the topping, with some shear taken by the reinforcing bar. The relative shear values shown were based upon the relative shear stiffnesses of the topping and associated bar. The point to be made is the fact that the vertical shear acting through the tile (the portion taken by the bar) is much less than the total shear (which is essentially the shear taken by a conventional beam web). A significant effect of this unusual distribution of free-body forces can be seen by summing moments about the underside of the top flange of the tile (point A on Section A-A). An example based on the estimated free-body forces that existed immediately preceding the collapse, on a section of floor located between 2 and 3 ft from a supporting wall, is provided in Fig. 8. As indicated in Fig. 8, the tile walls sustain substantial vertical tensile stresses along the horizontal plane that intersects point A—stresses that would be insignificant if the walls of the tile were not discontinuous. In contrast, if shorter tile units were used, the tensile stresses in the wall elements would be greater in magnitude than those shown in Fig. 8. As indicated previously, one transverse row of tiles located near one end of the

For a given loading, the compression force in the topping and the tension force in the reinforcing steel at any cross section are equal in magnitude and opposite in sign. This situation is shown in Fig. 7. In addition, for a particular loading, the magnitude of the compression and tension forces at a given cross section is a function of the vertical distance between their respective points of application. If this distance were to decrease while all other things remained constant, the magnitude of the compression and tension forces would increase proportionally. Furthermore, any increase in reinforcing bar tension would cause a proportional increase in the tile wall tension stresses.

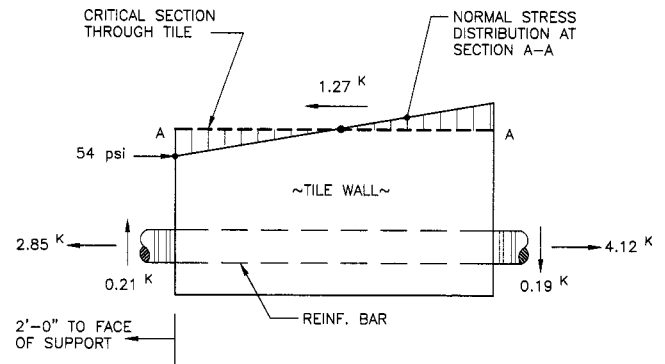
Fig. 8. Free body diagram below critical section

failed floor consisted of units that were only 4 in. long. Furthermore, the tile tensile stresses shown in Fig. 8 were calculated assuming the tile walls were solid. Given the fact that core samples showed that the walls contain extensive planar discontinuities in the critical areas, actual stresses immediately preceding the collapse were almost certainly much higher at most locations where similar shear forces were present.

While the general force transfer mechanism shown in Figs. 7 and 8 applies at virtually every location in a particular STDS, the magnitude of the vertical tensile stress is proportional to the difference between the reinforcing steel tension forces acting at each end of the tile. In other words, the local tile wall vertical stress magnitude is proportional to the global moment gradient, which in turn is proportional to the global shear force. Based on the analysis results summarized in Fig. 8, several wall/flange tile fractures would have been expected in the subject floor as soon as the construction shoring was removed. Although these fractures would have been concentrated primarily in the higher shear areas, near the supporting walls, tensile stresses sufficient to fracture the weakest tiles probably occurred several feet from any support.
